# Hydrogeological Assessment, 1697 Durham Regional Highway 2, Courtice

January 26, 2024

Prepared for:  
Richard H. Gay Company Limited

Cambium Reference: 15382-002

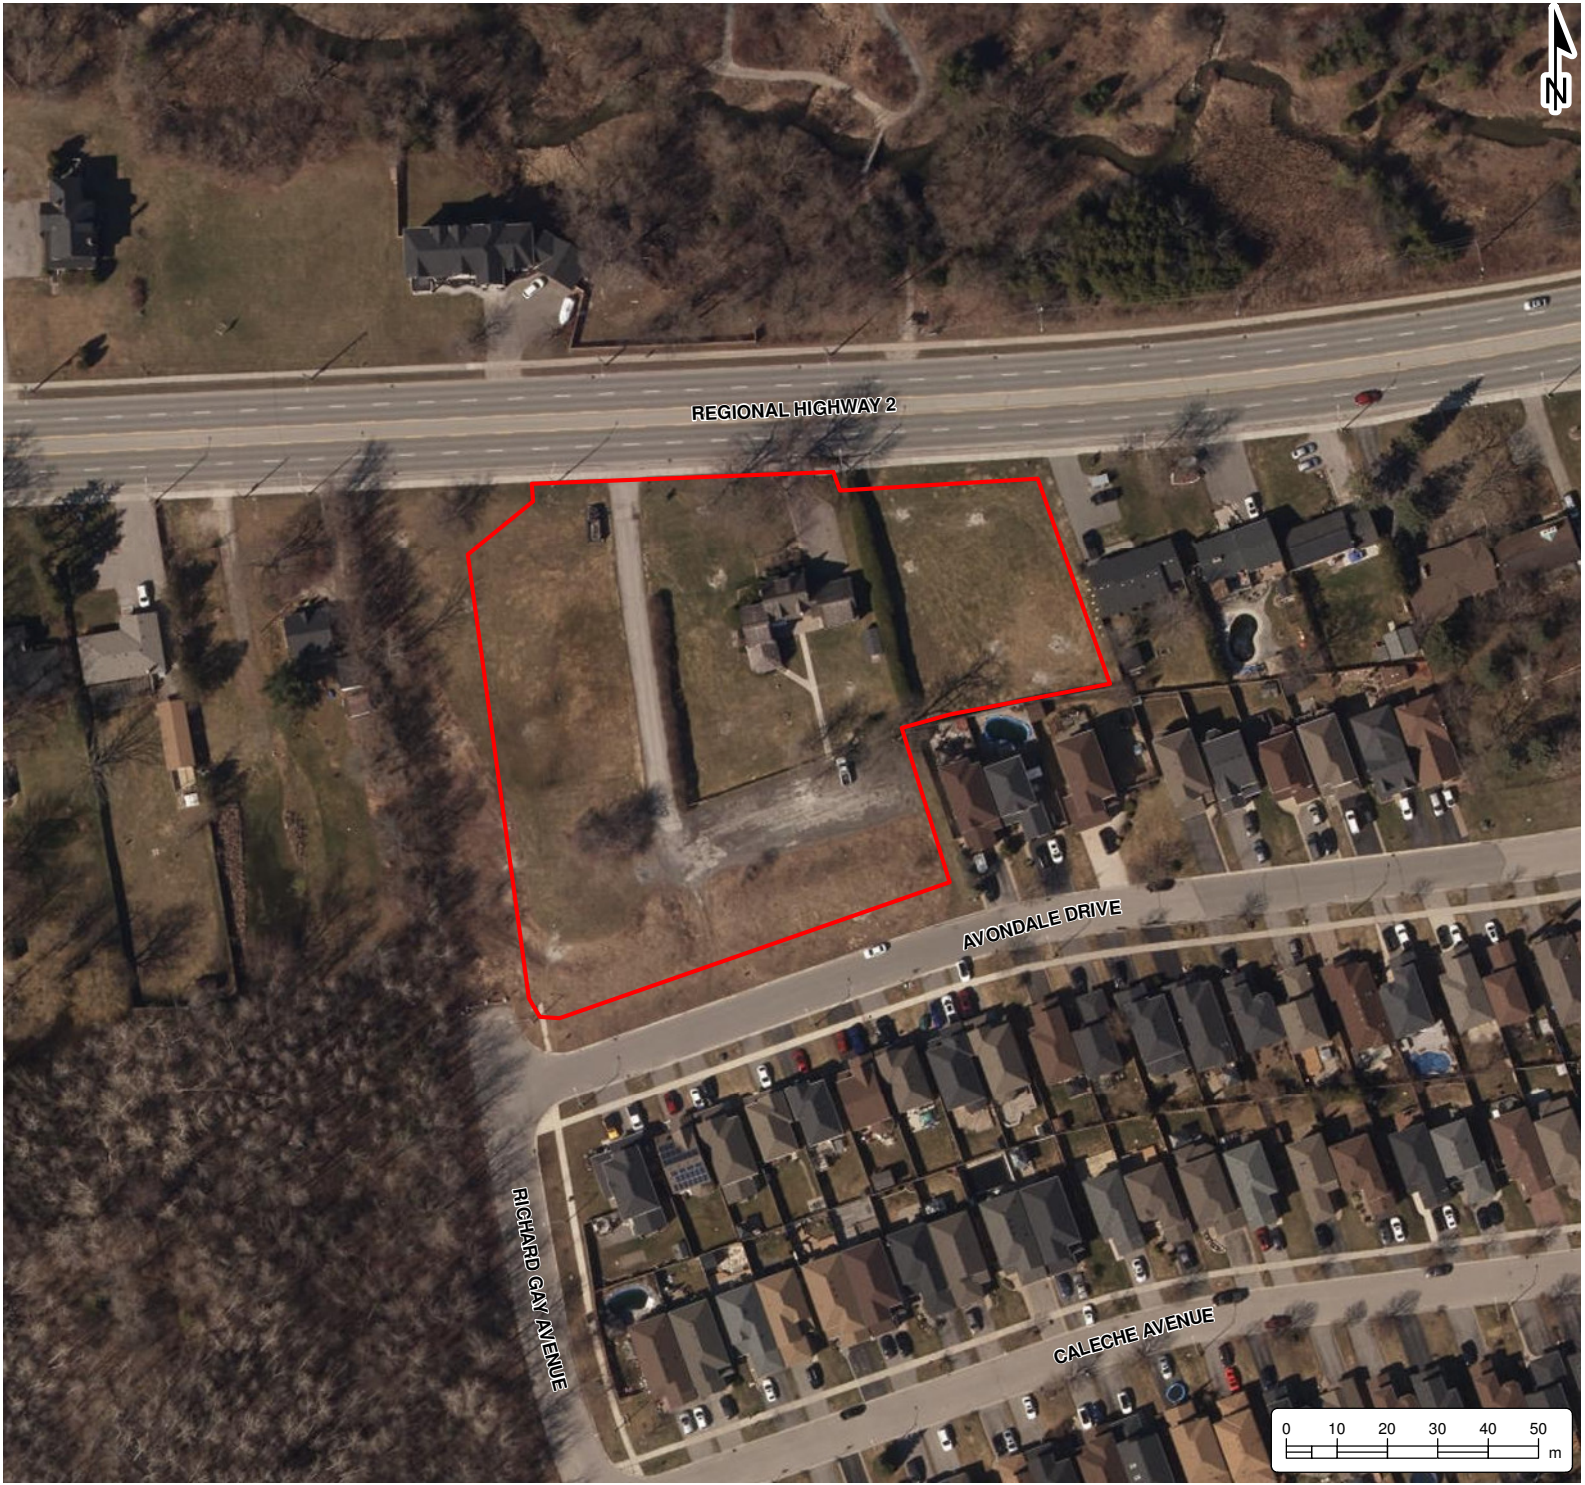
Project No.:	15382-002	Date:	December 2022
Scale:	1:1,500	Rev.:	
Created by:	DBB	Checked by:	KH
		Figure:	<b>2</b>

**SITE PLAN**

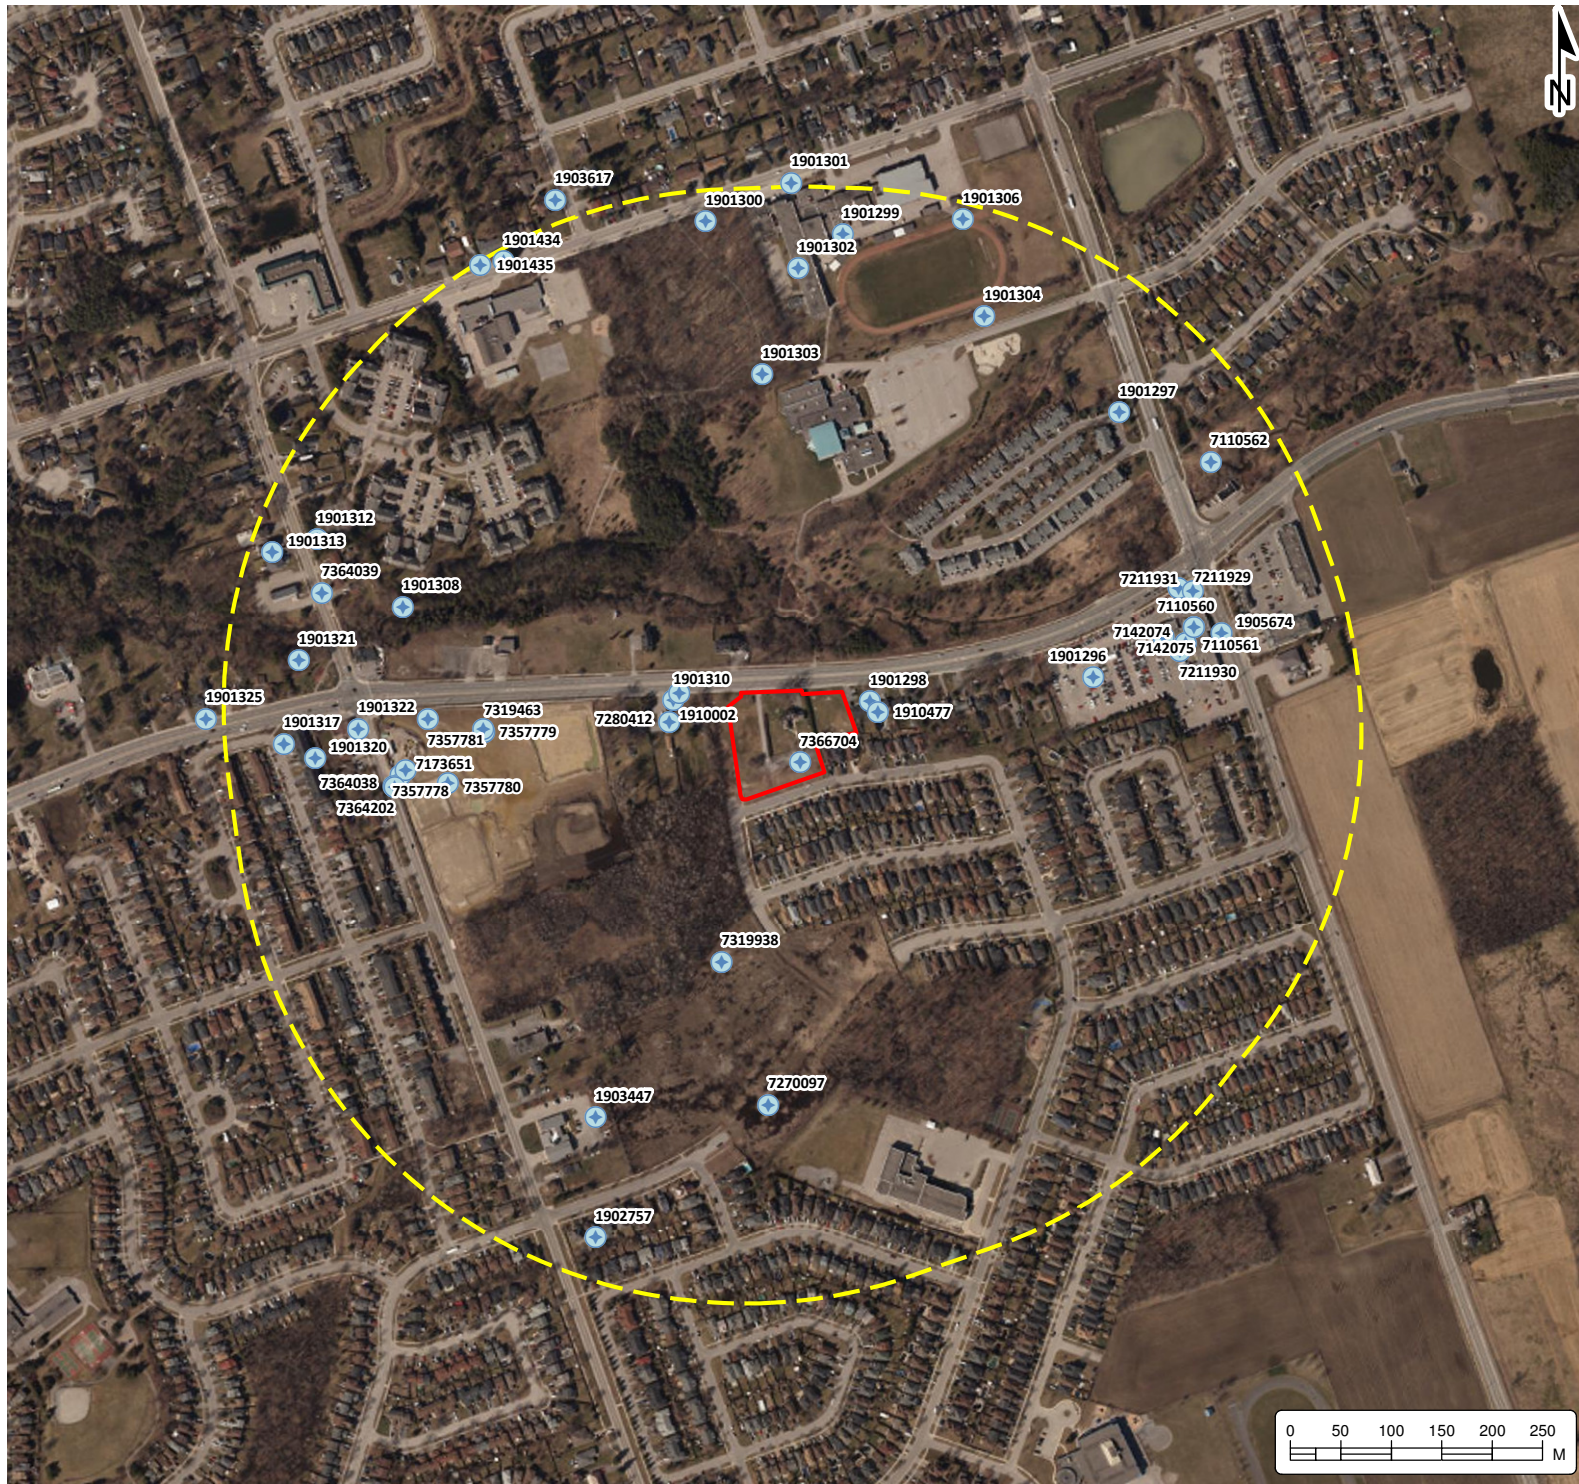
Project No.:	15382-002	Date:	November 2022
Scale:	1:7,500	Rev.:	
Created by:	PAS	Projection:	NAD 1983 UTM Zone 17N
Checked by:	KH	Figure:	<b>3</b>

Forty-seven well records within a 500 m radius were found and can be seen in Figure 3. All the well records were for wells that were installed in overburden, except for 1 abandoned water quality well that was drilled into black shale bedrock. Twenty-three wells were drilled as supply wells, with six of these wells listed as abandoned. Eighteen wells were classified as monitoring, observation, or test wells, with four wells abandoned. There were 5 overburden wells that had information on the well use in the well record. A summary of the well information is provided in Embedded Table 2.

The maximum estimated radius of influence during either construction or operational dewatering is 14 m. The nearest private water supply wells are greater than 14 m from the outer edge of the foundations of the proposed buildings (Figure 3); therefore, no significant impacts to surrounding water users are expected as a results of dewatering at the Site.

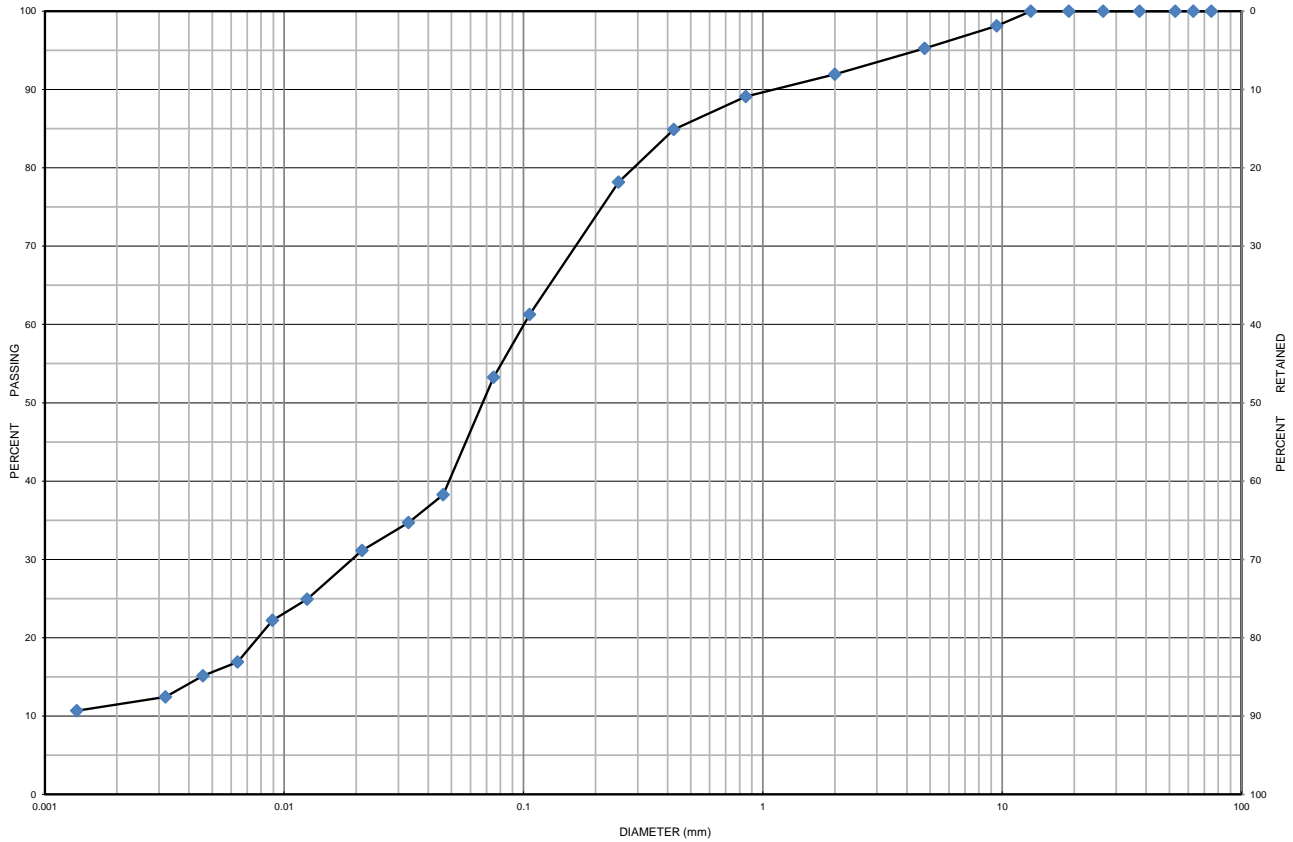
Borehole No.	Sample No.	Depth	Gravel	Sand	Silt	Clay	Moisture
BH 101-22	SS 10	10.7 m to 11.1 m	5	42	41	12	16.7
Description		Classification	D <sub>60</sub>	D <sub>30</sub>	D <sub>10</sub>	C <sub>u</sub>	C <sub>c</sub>
SILT and SAND		ML/SP	0.110	0.019	-	-	-

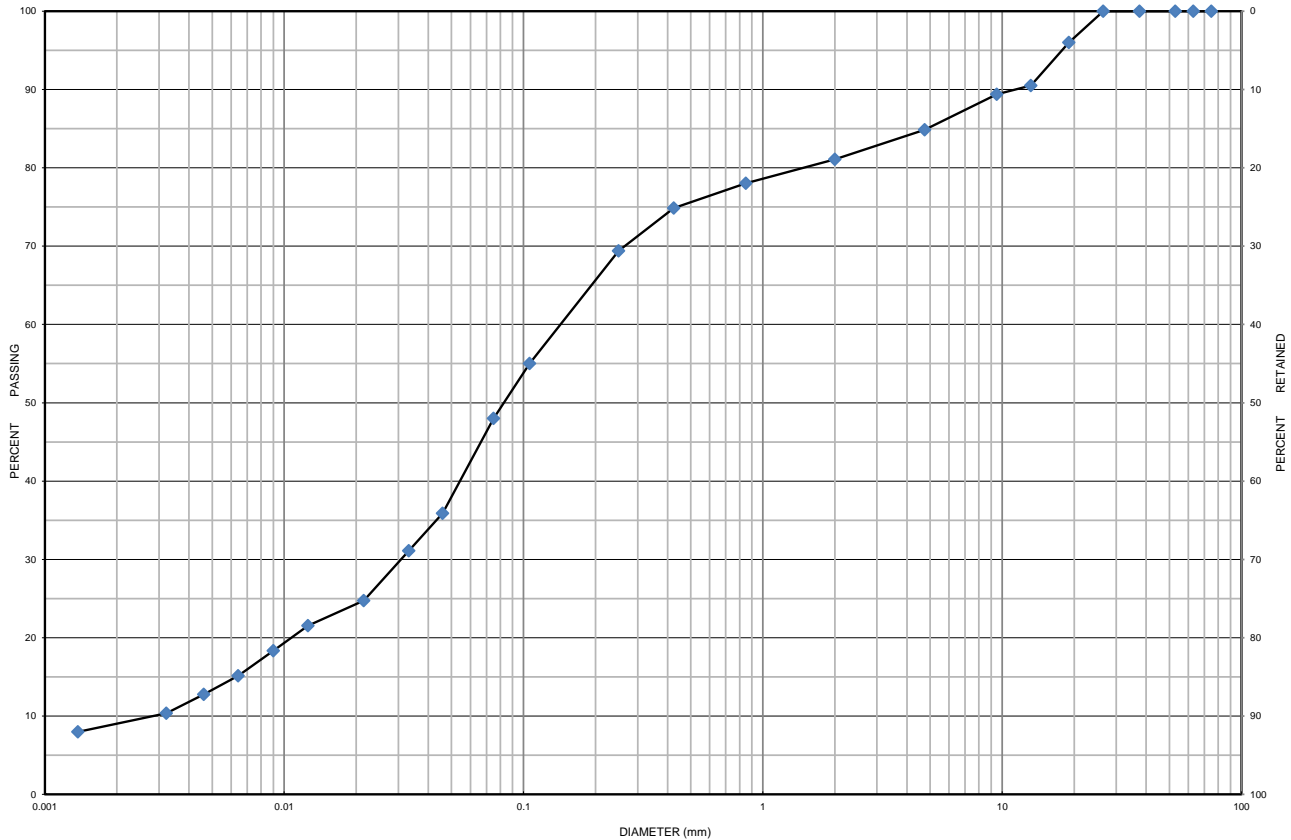
Borehole No.	Sample No.	Depth	Gravel	Sand	Silt	Clay	Moisture
BH 101-22	SS 14	16.8 m to 17.2 m	15	37	40	8	10.9
Description		Classification	D <sub>60</sub>	D <sub>30</sub>	D <sub>10</sub>	C <sub>u</sub>	C <sub>c</sub>
Sandy SILT to SILTY SAND TILL		ML/SM	0.1500	0.0310	0.0026	57.69	2.46

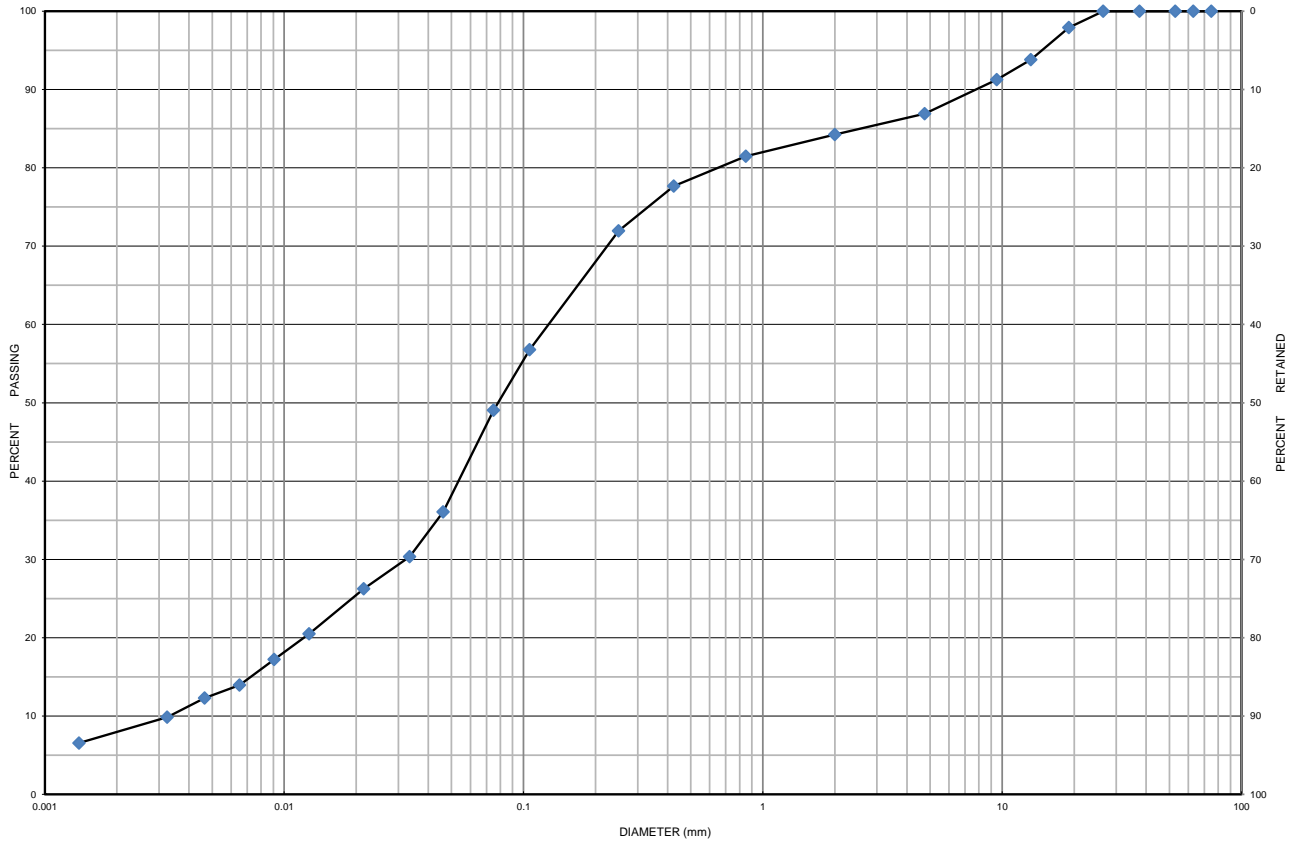
Borehole No.	Sample No.	Depth	Gravel	Sand	Silt	Clay	Moisture
BH 105-22	SS 9	10.7 m to 11.1 m	13	38	41	8	12.0
Description		Classification	D <sub>60</sub>	D <sub>30</sub>	D <sub>10</sub>	C <sub>u</sub>	C <sub>c</sub>
SILT and SAND		ML/SP	0.1400	0.0320	0.0033	42.42	2.22

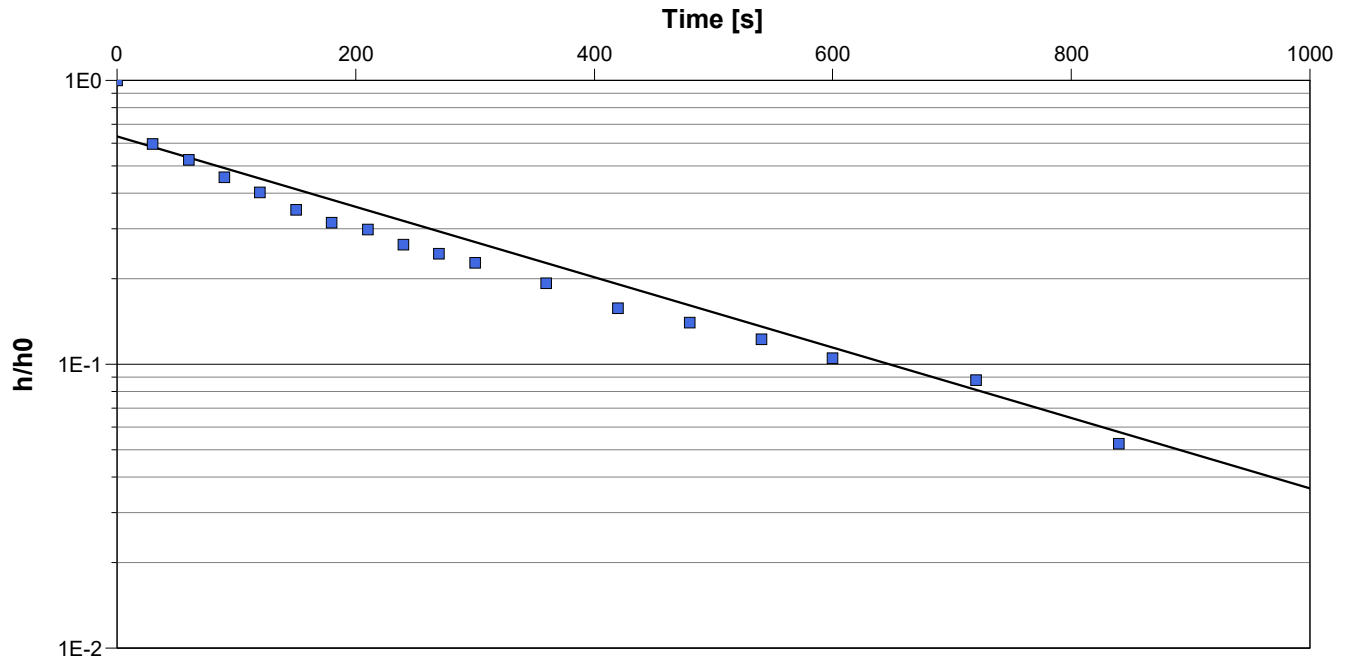
Location: 1697 Durham Reg. Hwy 2	Slug Test: BH106	Test Well: BH106
Test Conducted by: W. Young		Test Date: 11/24/2022
Analysis Performed by: W. Young	Slug Test Analysis - Hvorslev	Analysis Date: 11/30/2022
Aquifer Thickness: 0.57 m

Calculation using Hvorslev		
Observation Well	Hydraulic Conductivity [m/s]	
BH106	$2.42 \times 10^{-6}$

The hydraulic conductivity of the geological formation adjacent the BH106-22 was estimated via the Aquifer Test Pro slug test software using the Hvorslev interpretation method. The result of the hydraulic test is presented in Embedded Table 4 and the analytical data can be found in Appendix E. The estimated hydraulic conductivity of the native overburden of  $2.42 \times 10^{-6}$  m/s is
