November 6, 2019  
(Revised January 27, 2020)

Project No. 1791121

**PHASE ONE ENVIRONMENTAL SITE ASSESSMENT UPDATE,  
WINDFIELDS FARM DEVELOPMENT SITE, "PARCEL D", OSHAWA, ONTARIO**

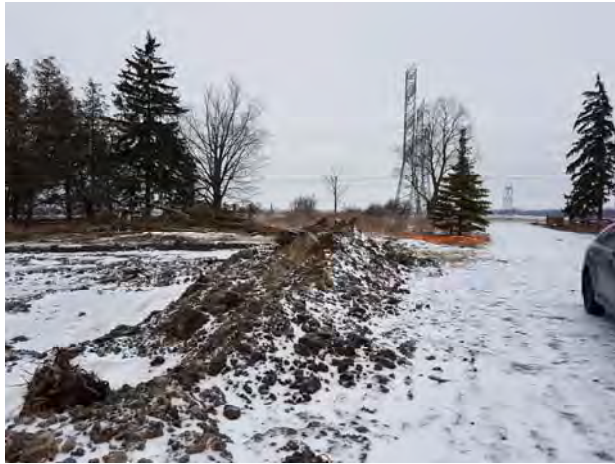
Photo 1 – View of the former location of House 46, looking north from the northern end of the Site.

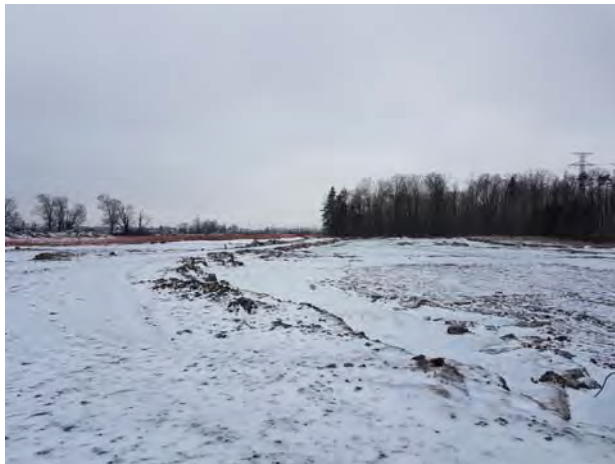
Photo 2 – View of the central-northern portion of the Site, looking west from the former yard of House 46.

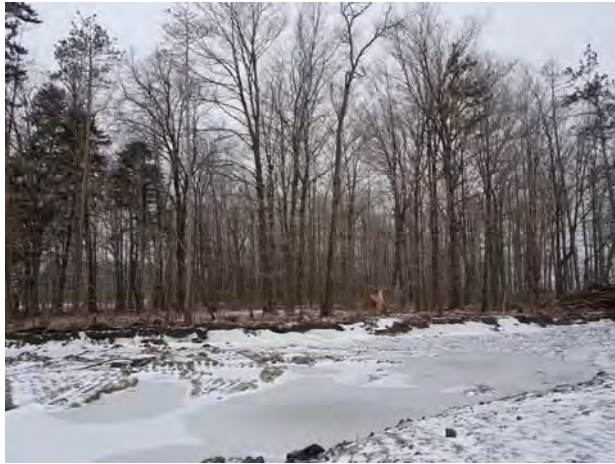
Photo 3 – View of the wooded lot located in the north-western portion of the Site.

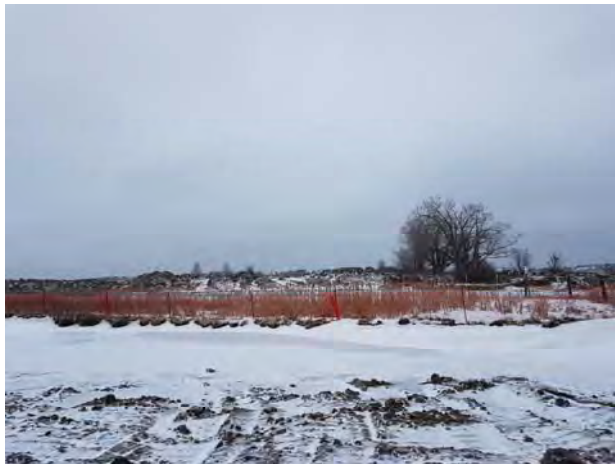
Photo 4 – View of orange plastic fencing tracing the path of the natural gas easement crossing the Site.

- Although not specifically noted in the 2015 Phase One ESA report, natural gas pipelines owned by TransCanada Pipelines and Enbridge Gas traverse the central portion of the Site within a dedicated easement. A cleared strip through the woodlot in the northwestern portion of the Site (location of the pipeline easement) was first noted in the 1964 aerial photograph (of those reviewed in the 2015 Phase One ESA Report);

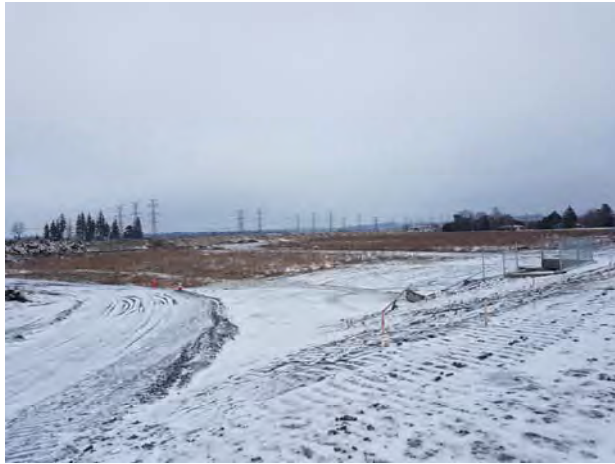
Photo 5 – View of the Site, looking north from the southern property boundary. The hydro transmission lines visible are located to the north of the Site, north of Winchester Road East.

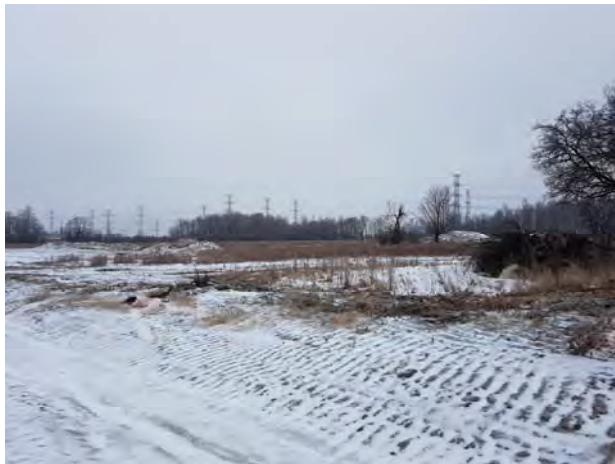
Photo 6 – View of the south-western portion of the Site, looking northwest from the southern property boundary.

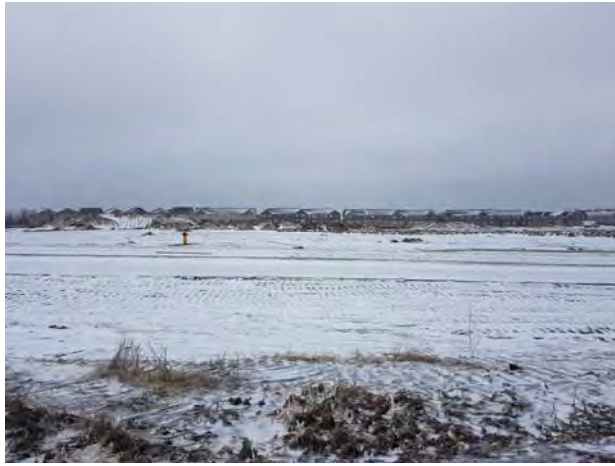
Photo 7 – View of the surrounding property to the south of the Site, including a vacant field to the south of which are newly built residential dwellings.

- The properties east, southeast and south of the Phase One Property had been redeveloped with residential dwellings and residential dwellings under construction since the 2015 Phase One ESA Report. Several electrical transformers were observed to have been installed throughout the new residential development in the Phase One Study Area. No other significant changes to surrounding property use since the 2015 Phase One ESA were observed at the time of the February 2019 Site visit ;

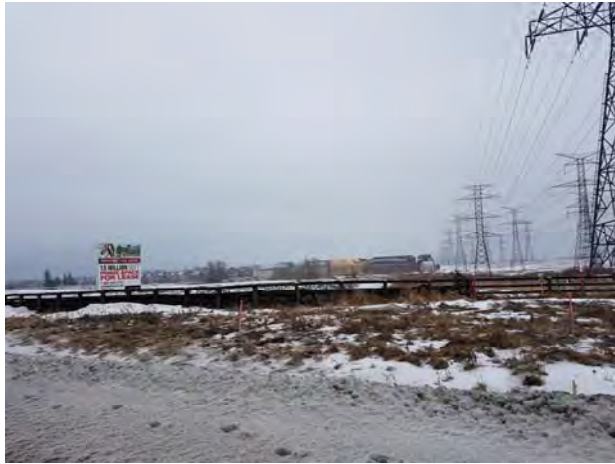
Photo 8 – View of the land adjacent to the west of the Site, looking west from Simcoe Street North.
